## B&S - Jet Line Piping Overpressure

Investigation # 23397

21 Pump Station -B&S Division

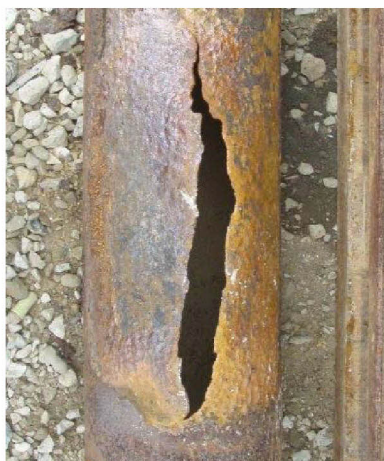
Picture of the failed 8" JP5 piping.

- 1) The buried piping failed as a result of external corrosion. With very thin piping and no thermal relief for a short period of time, the piping ruptured.
- 2) The JP5 line was installed using past practices of using an old pipe as a pipe sleeve under road crossings. This old pipe sleeve had failed and allowed soil and water to enter into the sleeve and come into contact with the JP5 piping. The presence of soil and water caused external corrosion of the JP5 line.
- 3) Several piping runs, including the pipe that failed, are still packed with product that were apart of the JP5 Filter system. No proper air gapping or flushing of the piping was performed when the system was taken out of service 15 years ago.

- 1) Reinforce the current buried piping standards found in Chevron Engineering Standards so that future installation is conducted in accordance with today's standards.
- 2) Continue with current buried piping inspection program, however, the team will now survey the conditions of all pipe sleeves in the surrounding area regardless of whether there is any product in the line or whether the pipe system is active to help identify any piping system that maybe experiencing external corrosion.
- 3) B&S shall develop and implement a plan to empty and clean the remaining systems that are currently out of service and require air gapping.
- 4) Reinforce the importance of stop work authority to all personnel.

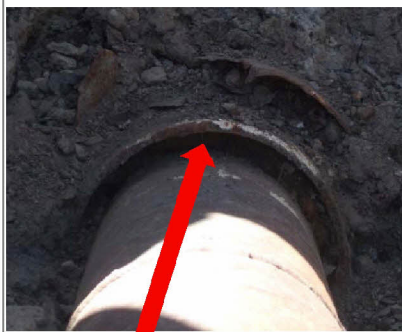
This is an example of poor design for buried piping systems; this JP5 line was in similar condition.
